NUMERICAL AND EXPERIMENTAL INVESTIGATION ON THE REPAIR IMPACT OF
ARROW-SHAPED AND HEXAGONAL GLASS-EPOXY COMPOSITE PATCHESMohammadjavad RANJBARAN¹, Seyed Masoud HOSSEINI²¹Graduate student (Islamic Azad University of Hamedan, Department of Mechanical Engineering, Hamedan, Iran)

Abstract

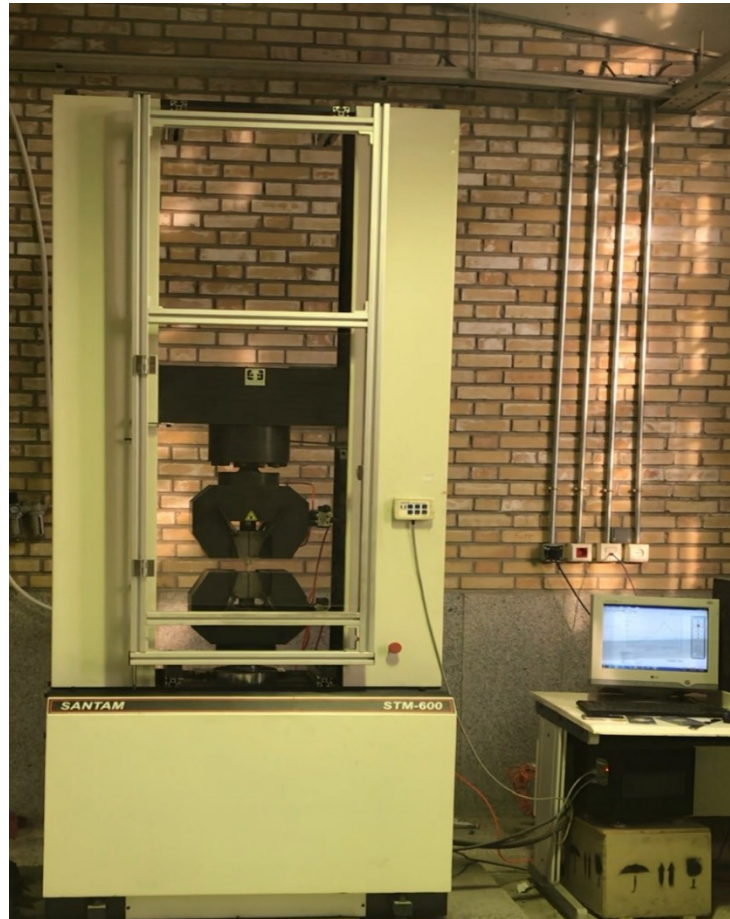
Figure 1: The 600 KN Santam Testing Machine

In the experimental part, the 600 KN Santam testing machine is employed to perform real tensile loading on the samples (Figure.1). Also, Abaqus software is used to numerically analyze and simulate the testing conditions.

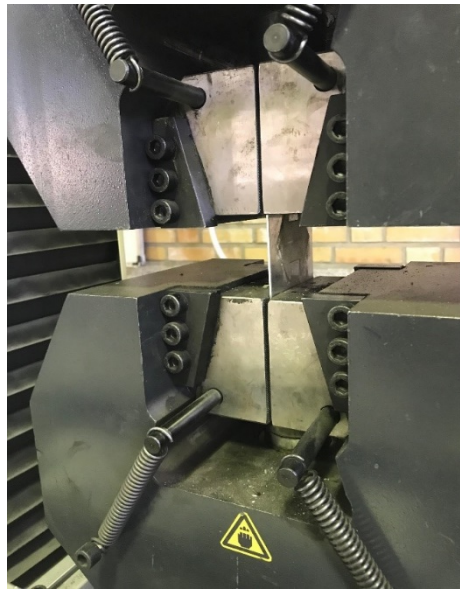
Figure 2: Positioning the Sample in the Load-cell

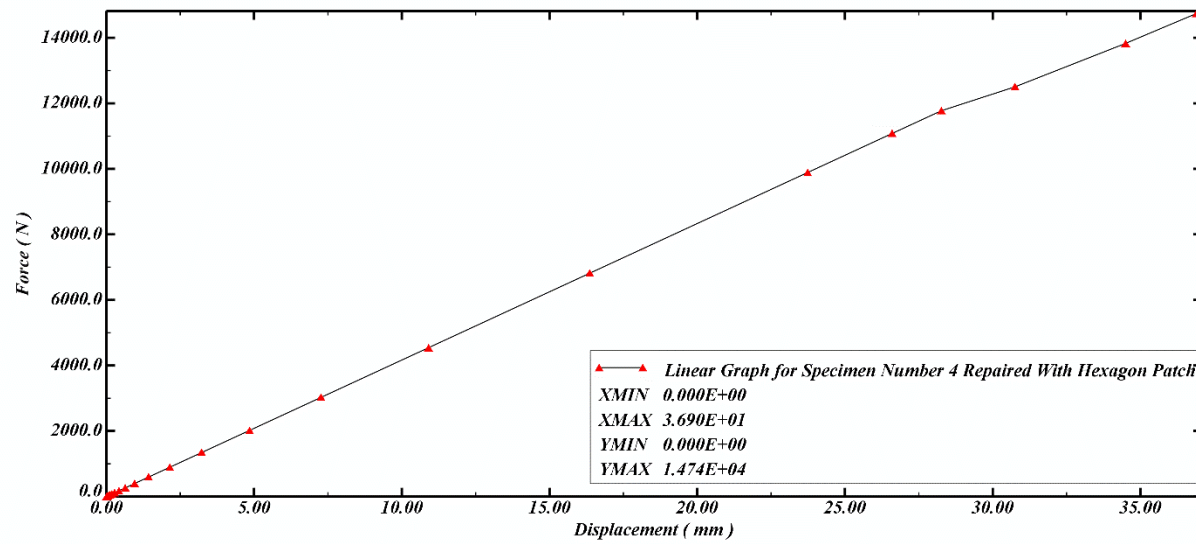
Figure 17: The Force-Displacement Curve for Specimen Number 4

Lastly, the simulated uniaxial tensile loading tests were performed for the repaired aluminum samples number 4 and 25. The results of numerical simulations of Misses stress distribution for both specimens and their Force-Displacement linear graphs were monitored and reported (Figures 15, 16, 17 & 18).
